**CERCLA  
COMBINED ASSESSMENT REPORT**

**Morris Paints and Varnish  
East St. Louis, Illinois  
ILD 096721063**

**PREPARED BY:  
ILLINOIS ENVIRONMENTAL PROTECTION AGENCY  
BUREAU OF LAND  
DIVISION OF REMEDIATION MANAGEMENT  
OFFICE OF SITE EVALUATION**

**3  
SEPTEMBER 2002**

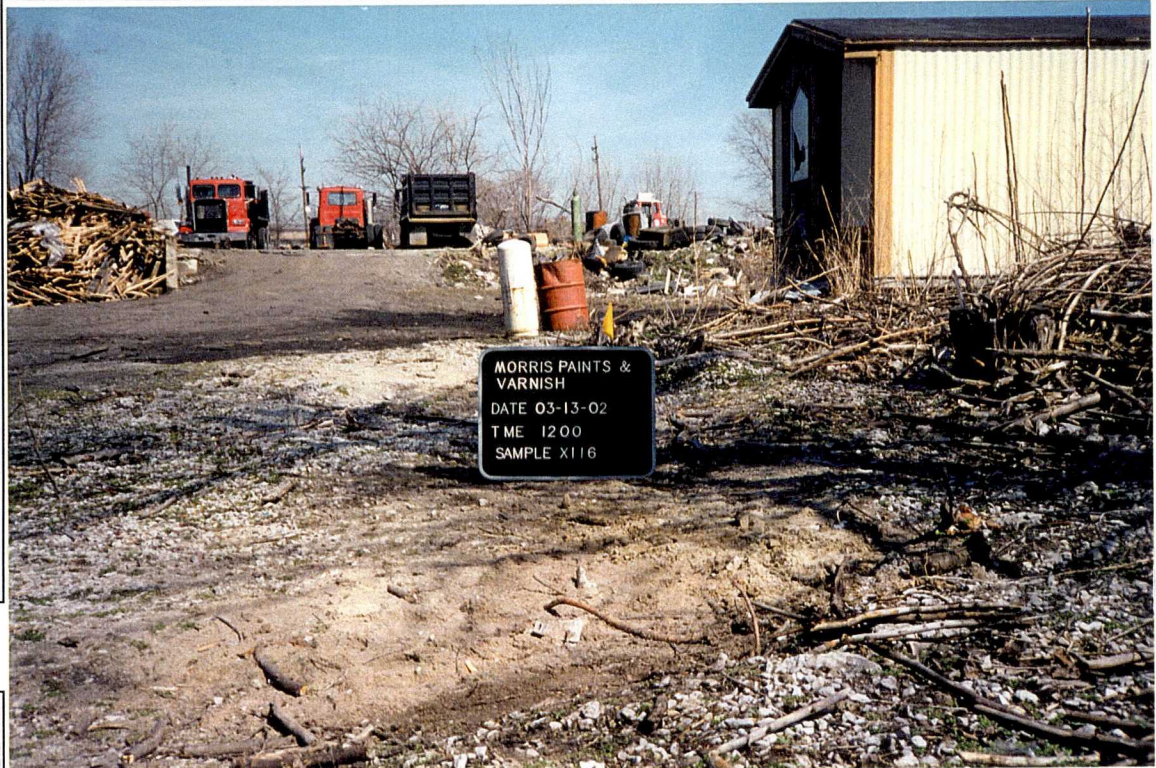
Photo Number 25.

Sample X116 was  
collected onsite  
in the southeast  
area of the  
property.

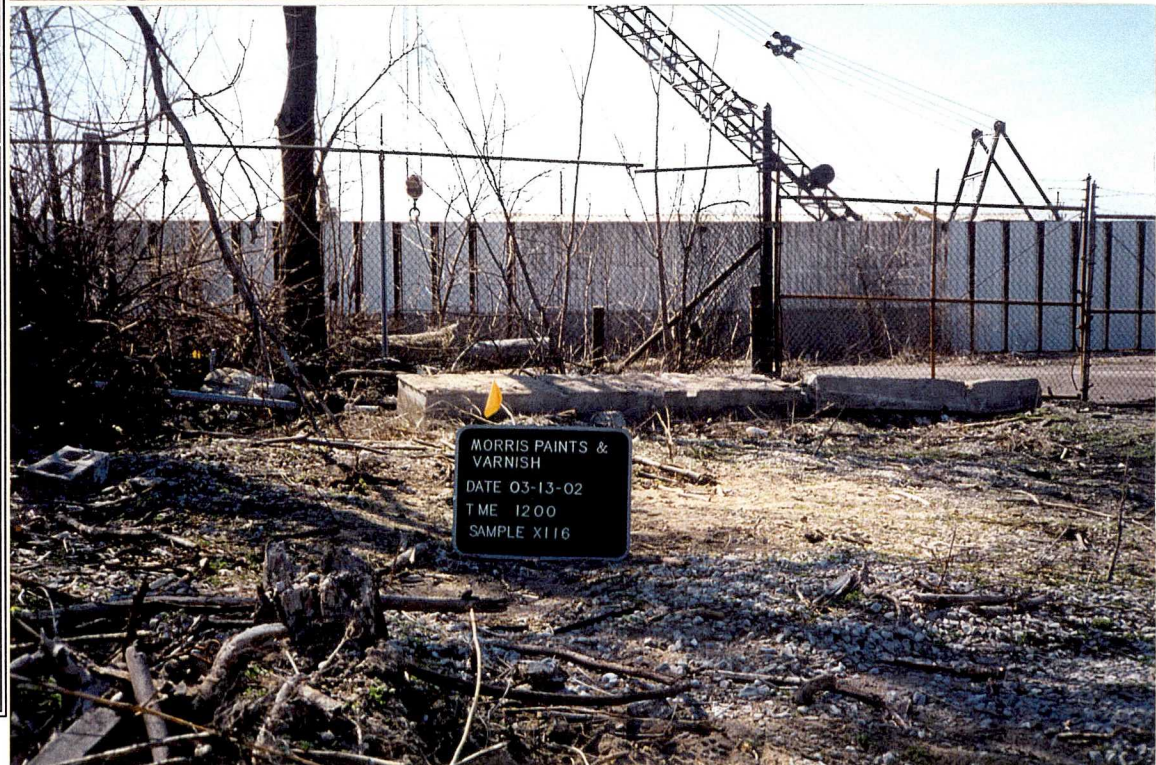
Photo Number 26.

Sample X116. The  
sample was collect-  
ed with the Geo-  
Probe at a depth  
of 3 to 50 feet.

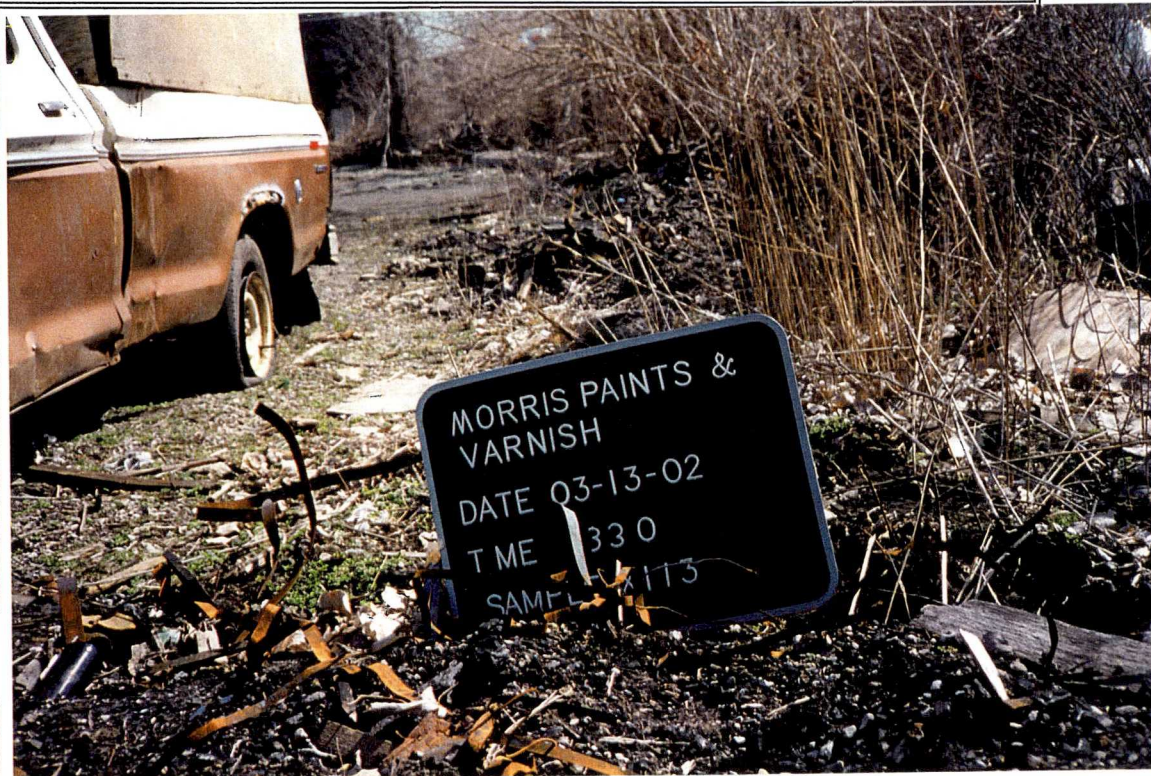
DATE: 3-13-02	SITE ILD#: 096721063	COUNTY: St. Clair
TIME: 13:30	SITE NAME: Morris Paints & Varnish	
PHOTOGRAPH TAKEN BY: R. Casper		
COMMENTS: Picture taken toward: Northwest.		
Photo Number 27.		
Sample X113 was collected onsite in the south area of the property.

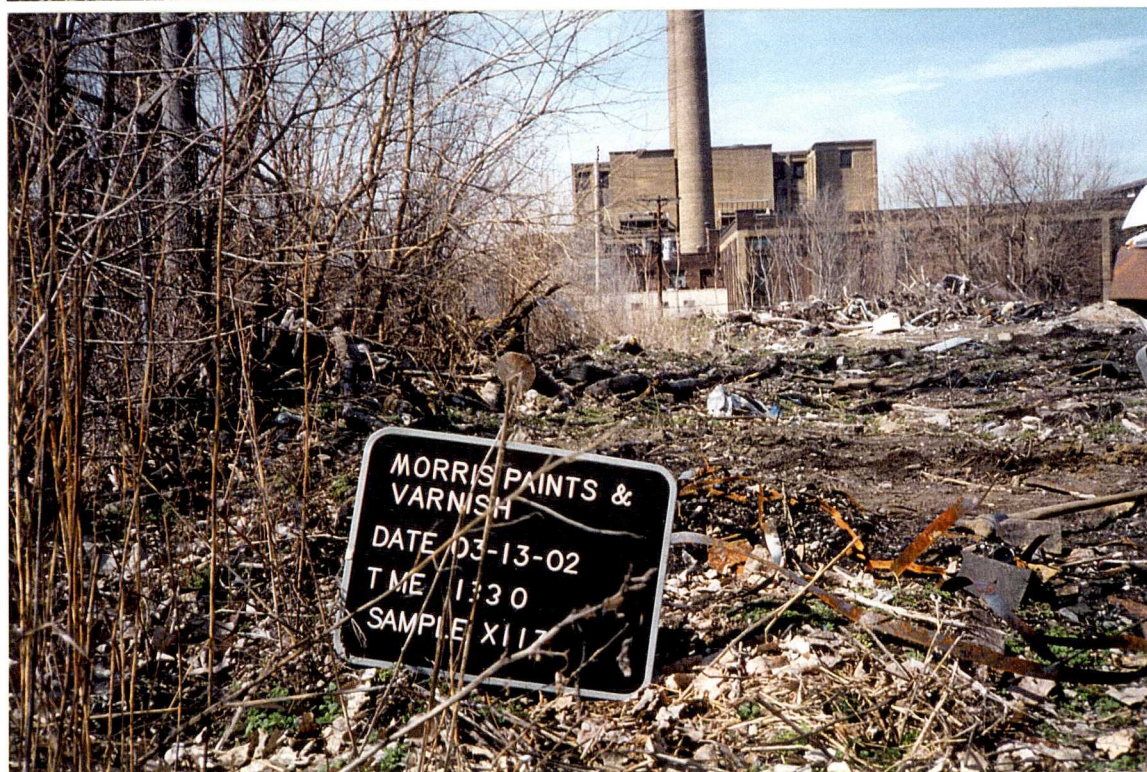
DATE: 3-13-02
TIME: 13:30
PHOTOGRAPH TAKEN BY: R. CASPER
COMMENTS: Picture taken toward: West.
Photo Number 28.
Sample X113. The sample was collected with a hand auger at a depth of 1 to 12 inches.

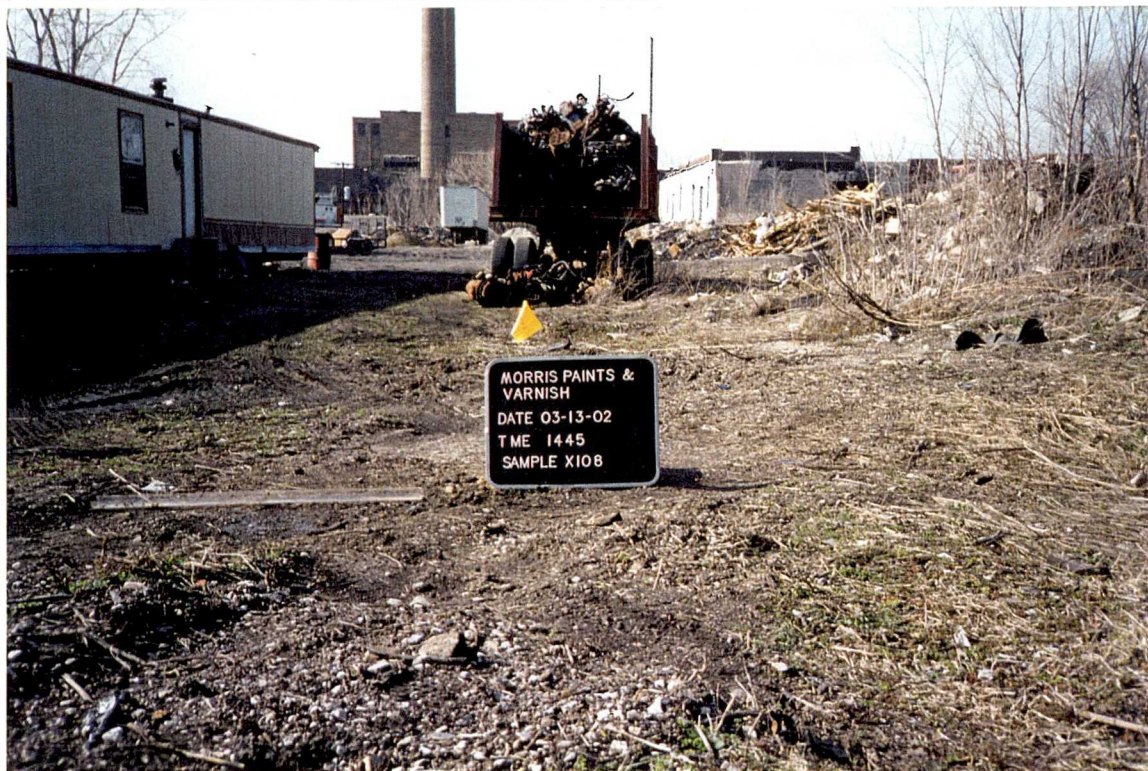
<u>X114</u> 3/12/02 14:45	Voa - 7' BNA/Pest-PCB - 7' Inorg. - Surface	Collected at the eastern area of the property, near site of former hotel.	0 to 3" - Loam, ciders, fine sand. 3" to 8" - White rock. 8" to 12" - Sandy loam, slag. 12" to 2' - Black cinders, loam, sand. 2' to 3' - Fine olive sand. 3' to 3.5' - Brown clayey sand. 3.5' to 8' - Brown fine sand. 8' to 12' - Tan fine sand.
<u>X115</u> 3/12/02 17:30	VOA - 7" BNA/Pest-PCB - 7" Inorg. - 3"	Collected at the southeast end of building, next to building foundation.	0 to 2' - Black sandy loam fill.
<u>X116</u> 3/13/02 12:00	VOA - 3" BNA/Pest-PCB - 2' - 4' Inorg. - 4' to 5'	Collected at the southeast area of property. Groundwater sample G101 and duplicate G102 also collected at this location.	0 to 1' - Brown sand, white rock. 1' to 15" - Black loam with some gravel. 15" to 2' - White rock. 2' to 7.5' - Brown clay & fine sand mix. 7.5' to 8' - Brown sand with thin clay layer. 8' to 26' - Brown fine sand.

PHOTOGRAPH TAKEN BY: R. Casper
COMMENTS: Picture taken toward: Northwest.
Photo Number 29.
Sample X114 was collected onsite in the eastern area
Note: photoboard has wrong sample No.

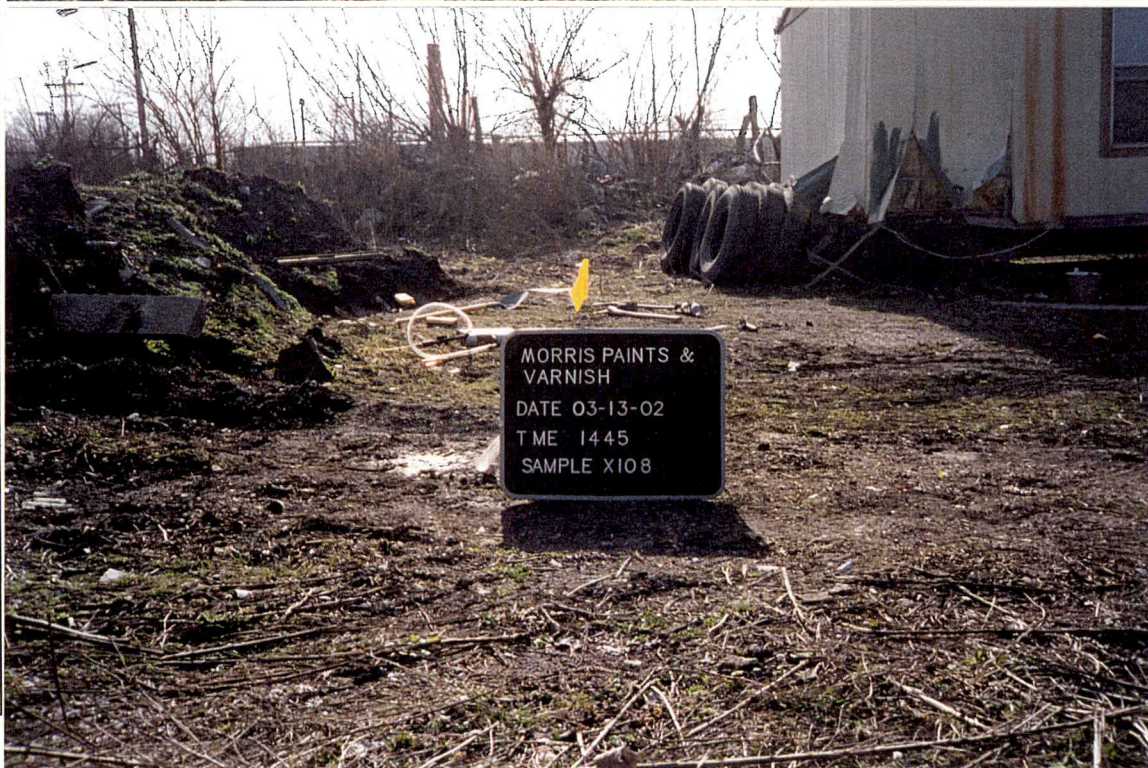
DATE: 3-13-02
TIME: 14:45
PHOTOGRAPH TAKEN BY: R. CASPER
COMMENTS: Picture taken toward: Southwest.
Photo Number 30.
Sample X114. The sample was collected at a depth of 7 to 8 feet. Note: Photoboard has incorrect sample No.

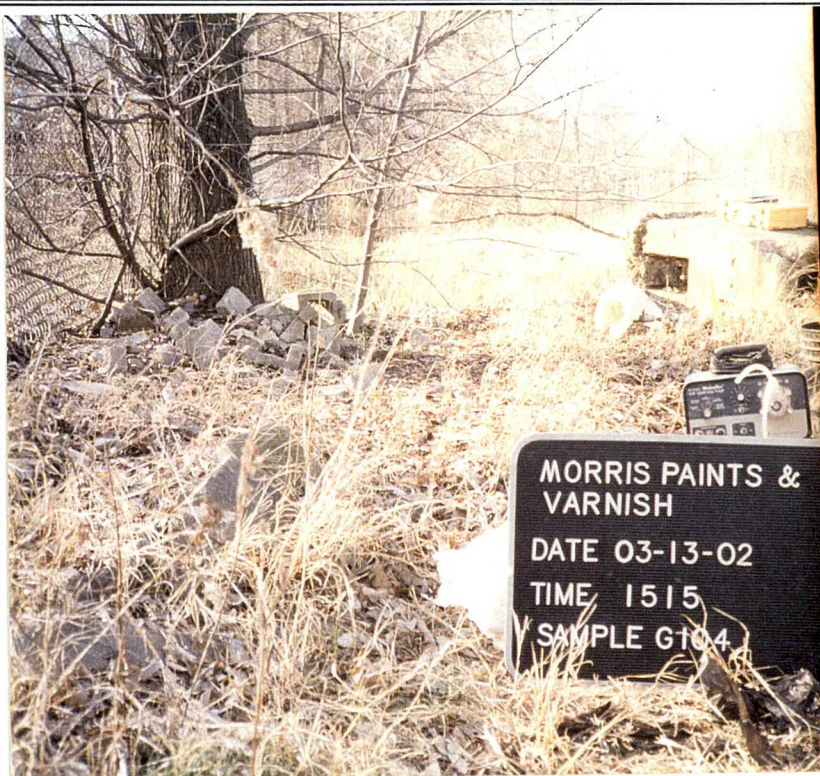
DATE: 3-13-02	SITE ILD#: 096721063	COUNTY: St. Clair
TIME: 15:15	SITE NAME: Morris Paints & Varnish	
PHOTOGRAPH TAKEN BY: R. Casper		
COMMENTS: Picture taken toward: Northwest.		
Photo Number 31.		
Sample G104 was collected offsite at the northeast corner of the property.

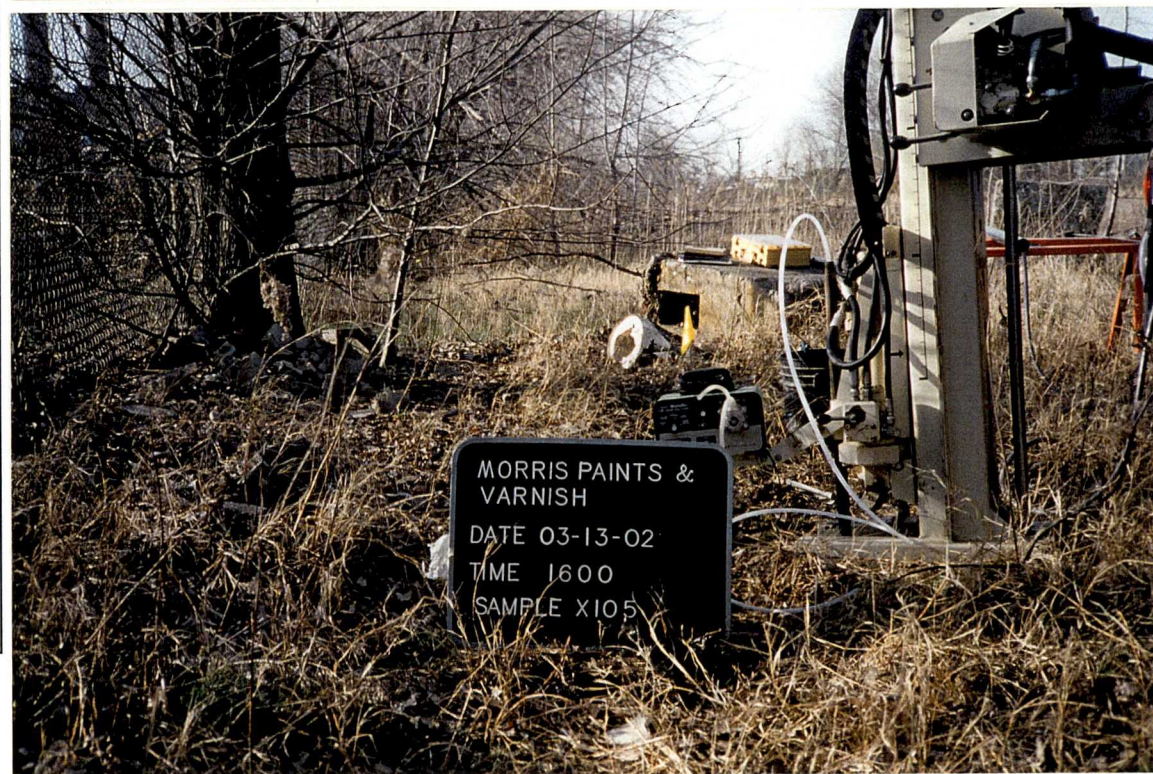
DATE: 3-13-02
TIME: 16:00
PHOTOGRAPH TAKEN BY: R. CASPER
COMMENTS: Picture taken toward: Northwest.
Photo Number 32.
Sample X105 was collected at the same location as G104.

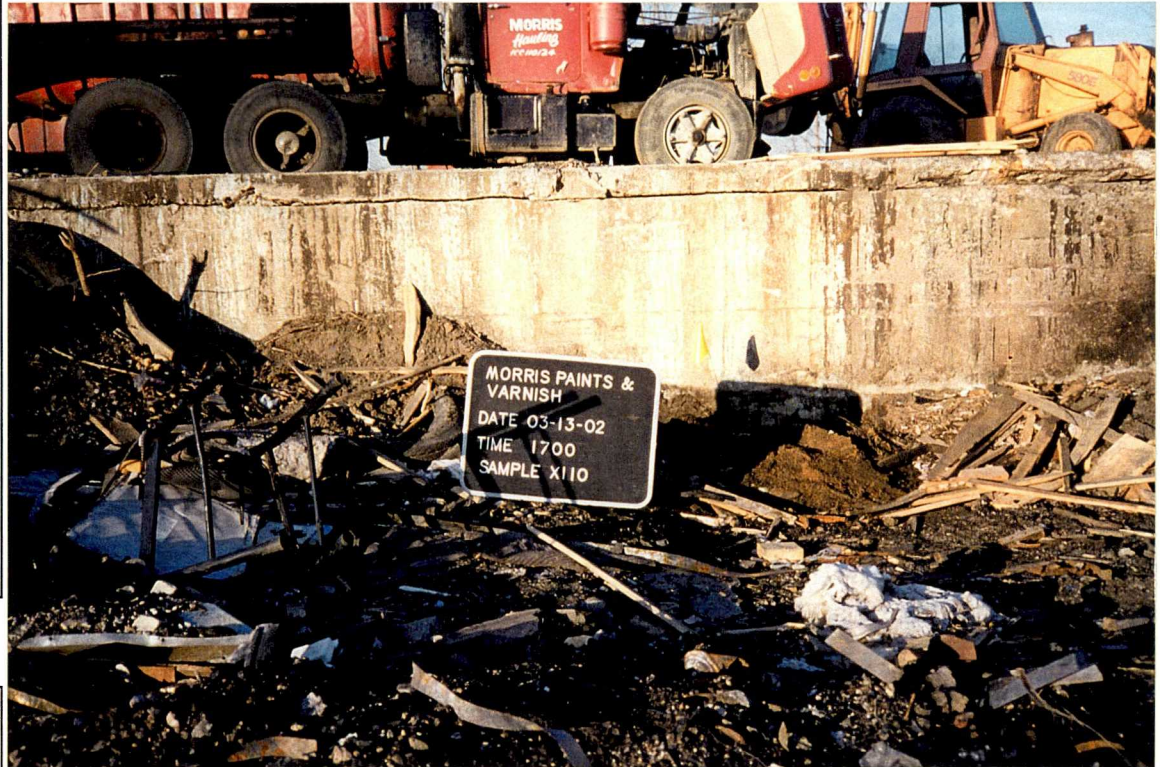
<u>X110</u> 3/13/02 17:00	VOA - 2' BNA/Pest-PCB - 2' Inorg.- Surface	Collected on the south side of concrete platform at site of demolished paint manufacturing building. Collected next to foundation.	0 to 4" - Black sandy loam. 4" to 18" - Red-brown sand. 18" to 2' - Black cinder material.
<u>X112</u> 3/12/02 16:30	2" to 12"	Collected at the southwest area of the property. Groundwater sample G103 also collected at this location.	0 to 6" - Dark brown loam with cinders. 6" to 2' - Gravel & cinders. 2' to 4' - Dark brown fine sand, gravel. 4' to 6' - Dark brown fine sand. 6' to 7' - Grey fine sand. 7' to 7.5' - Gravel & coarse brown sand. 7.5' to 8' - Grey-black fine sand. 8' to 9' - Fine black votes. 9' to 10' - Grey-dark brown clay, stiff. 10' to 11' - Sandy brown clay. 11' to 16' - Clayey brown sand. 16' to 23' - Fine brown sand. 23' to 24' - Fine-coarse brown sand.
<u>X113</u> 3/13/02 13:30	VOA - 1' BNA/Pest-PCB - 1' INORG. - 0 to 1'	Collected near the fence on the south-central area of the property.	0 to 1' - Black loam, cinders & sand. 1' to 2' - Fine red-brown slag. 2' to 5' - Fine dark brown sand, cinders. 5' to 6' - Fine brown sand.

PHOTOGRAPH TAKEN BY: R. Casper
COMMENTS: Picture taken toward: Northeast.
Photo Number 33.
Sample X110 was
collected onsite
by the south end
of the concrete
platform.

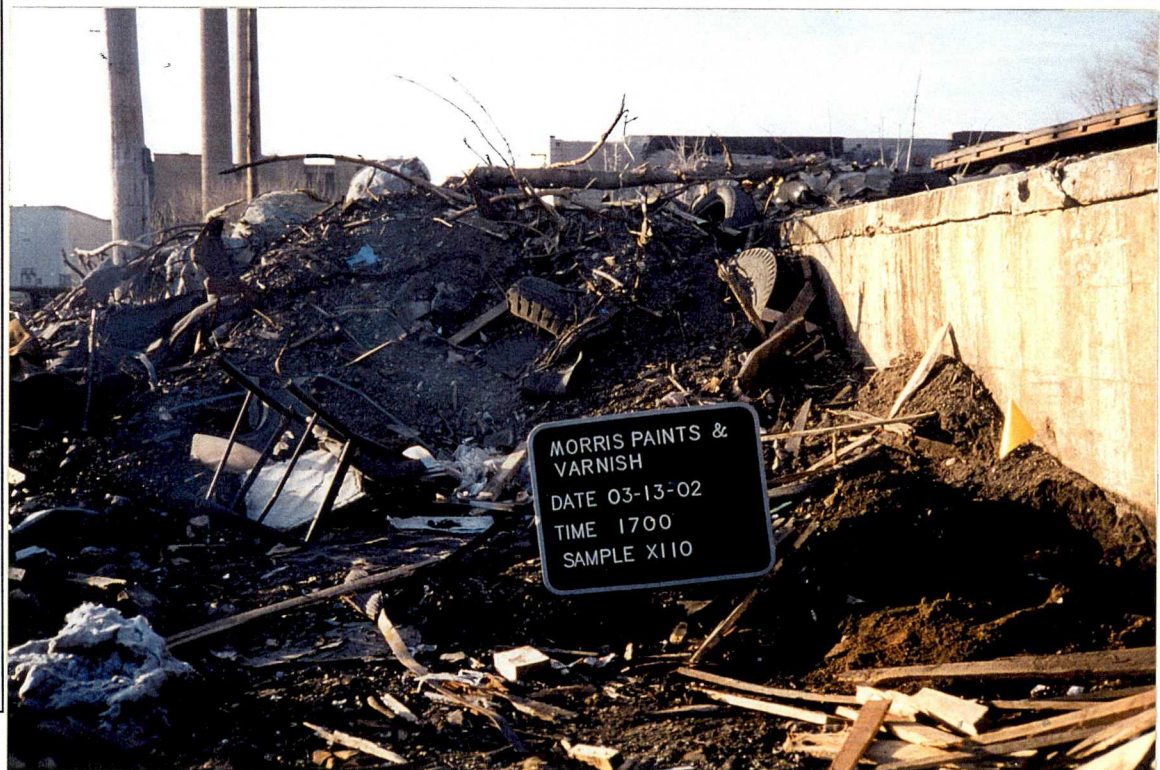
DATE: 3-13-02
TIME: 17:00
PHOTOGRAPH TAKEN BY: R. CASPER
COMMENTS: Picture taken toward: Northwest.
Photo Number 34.
Sample X110. The
sample was collect-
ed with a hand
auger at a depth
of 1 to 24 inches.
